TOTAL PERFORMANCE
VAN'S AIRCRAFT

SERVICE BULLETIN 14-01-31

Subject: Cracking near the bend in horizontal stabilizer front spar.

Affected Models: All RV-6/6A,7/7A,8/8A Flying or under construction

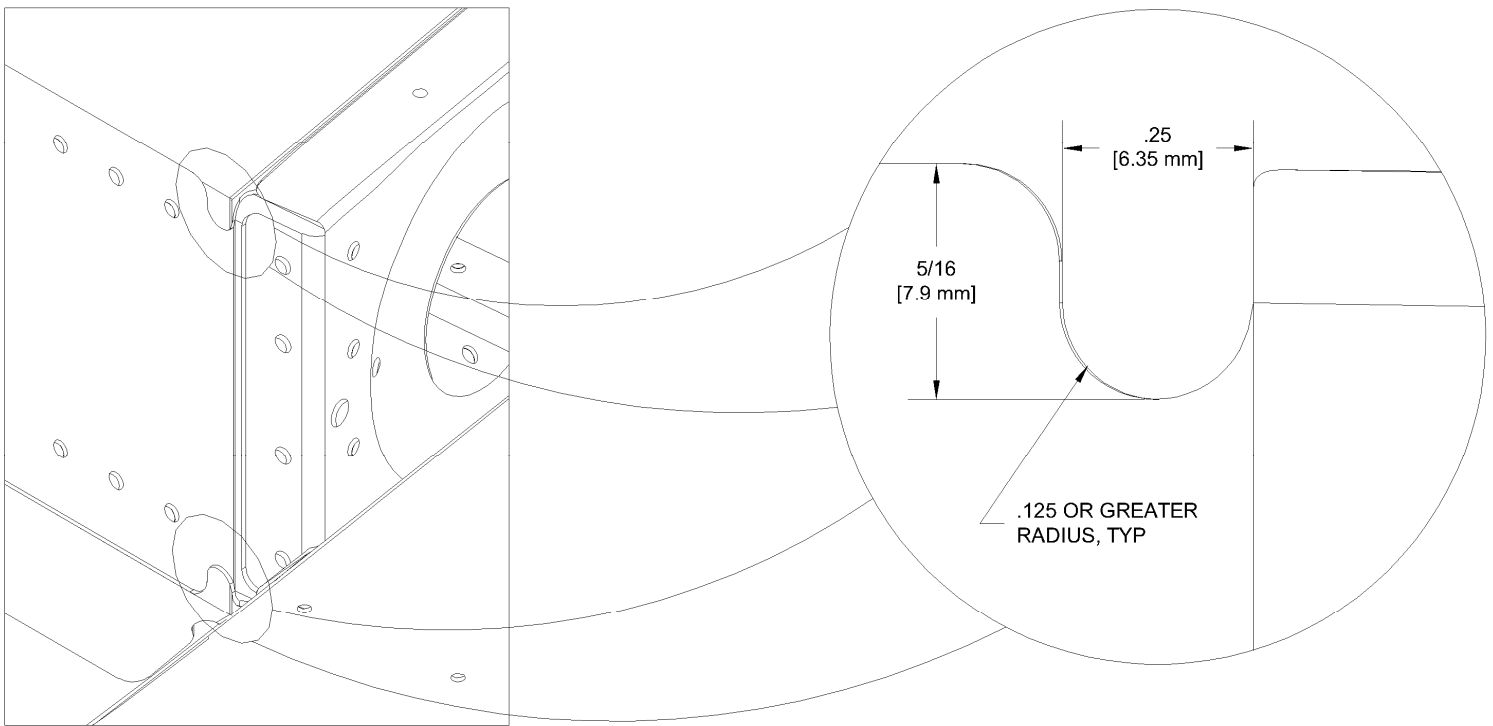
FIGURE 3: RELIEF NOTCHES

Step 8: Inspect the corners at the inboard end of the top and bottom fwd spar flanges on the left and right spar halves for the presence of relief notches as depicted in Figure 3.

If notches are not present, use a round file to add relief notches (first refer to the following step... adding a missing notch may be done in conjunction with removing a crack). This will require trimming the skin slightly as shown in Figure 2 to gain access for the file.

If cracks are 1/8 inch or shorter use a file to increase the size of the stress relief notch enough to remove the crack. File past the visible end of the crack 1/16 inch. Blend the shape of the filed away area by increasing the overall size of the relief notch.

If cracks are longer than 1/8 inch stop drill the crack using a #40 drill bit and then deburr.
